### **Knoxville Recreation Center**

Public Input and Information Session April 2, 2013

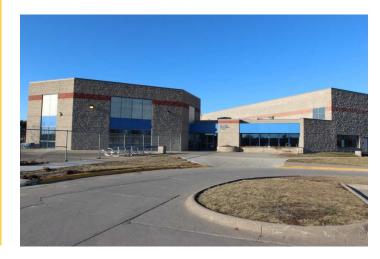
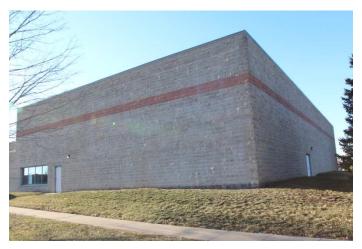
- Exterior and building envelope
  - Split-face Masonry cleaning, sealing and caulking
  - Translucent window panels need repair or replacement
  - Some signs of previous minor settling / CMU cracking
  - Minor grading, water management and sidewalk/stoop repairs
  - Repairs needed at rusted lintels and some exterior doors
  - Some leaking/problems at aluminum windows & patio doors
  - Roof membrane recently replaced
  - Building envelope is in fairly good condition

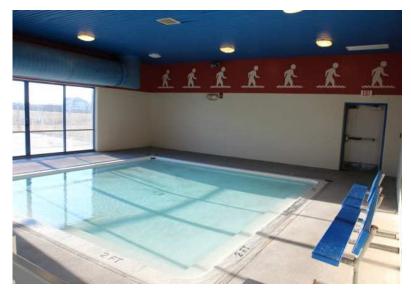
#### Natatorium

- Recirculation/treatment system for both swimming pools is connected
- Wading pool is under utilized and pool bottom slopes at 15%
- Concern noted with gutter edges and deck slope drains towards pool
- Recommend review of diving board heights relative to 10' water depth
- Review ADA railings and hot tub accessibility
- Windows, doors, & translucent panels in need of repair
- Need for ongoing preventative maintenance for rust issues

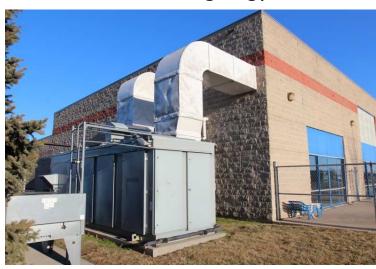
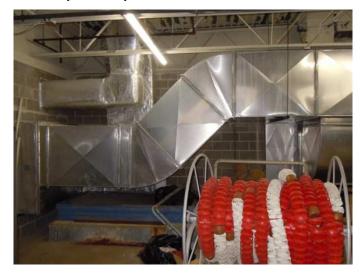
- Mechanical Electrical and Plumbing
  - One air handler serving gym is older/original to the building
  - Roof top unit serving racquetball and weight room is older/original
  - Daktronic Dehumidification System recently replaced (2003)
  - Plumbing piping is copper and is in acceptable condition
  - Past requests for individual showers in Men's locker room
  - Electrical system appears to be functional and expandable
  - There are concerns with internet service & existing A/V-Sound systems
  - Lack of cooling in gym is a deterrent to participation in the summer

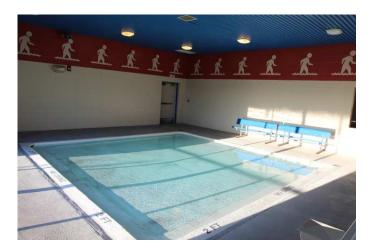
#### Natatorium

- Shallow pool under utilized consider revisions
- Slides or play features are desired
- Aqua therapy is desired
- Consider splash pad or spray features
- Interested in children's play area

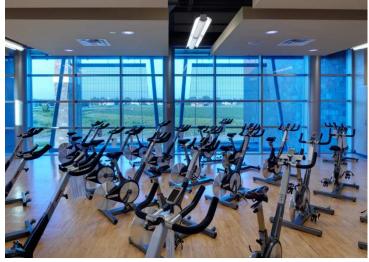
- New Designated Fitness Studio Space
- Future Family Gym / Multi-purpose space
- Expanded and Improved Cardio Room
- Expanded and Improved Weight Room and Training Room

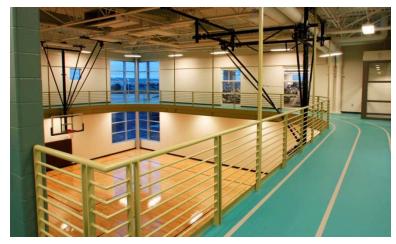
- Additional Gymnasium
  - Confirm if addition gym space is needed
  - Seating needs for events or tournaments
- Add a Family Gym or large multi purpose room
  - Gymnastics
  - Taekwondo
  - Youth activities

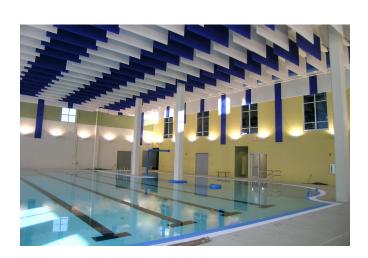
- Existing Natatorium code, life safety, and ADA upgrades
- Replace/revise shallow wading pool (family/aqua therapy)
- Remodel or expand indoor (6)-lane competition lap pool
- Add aqua play features (slides, floatables, or aqua sports)
- Children's play area or splash pad / sprays / zero-depth
- Additional Natatorium deck, spectator, or team staging area
- An Outdoor swimming pool / aquatic park
